ANNUAL REPORT FOR 2010

**Campbell Creek Phase II Mitigation Site
Beaufort County
TIP No. R-2510WM**

Natural Environment Unit & Roadside Environmental Unit
North Carolina Department of Transportation
December 2010

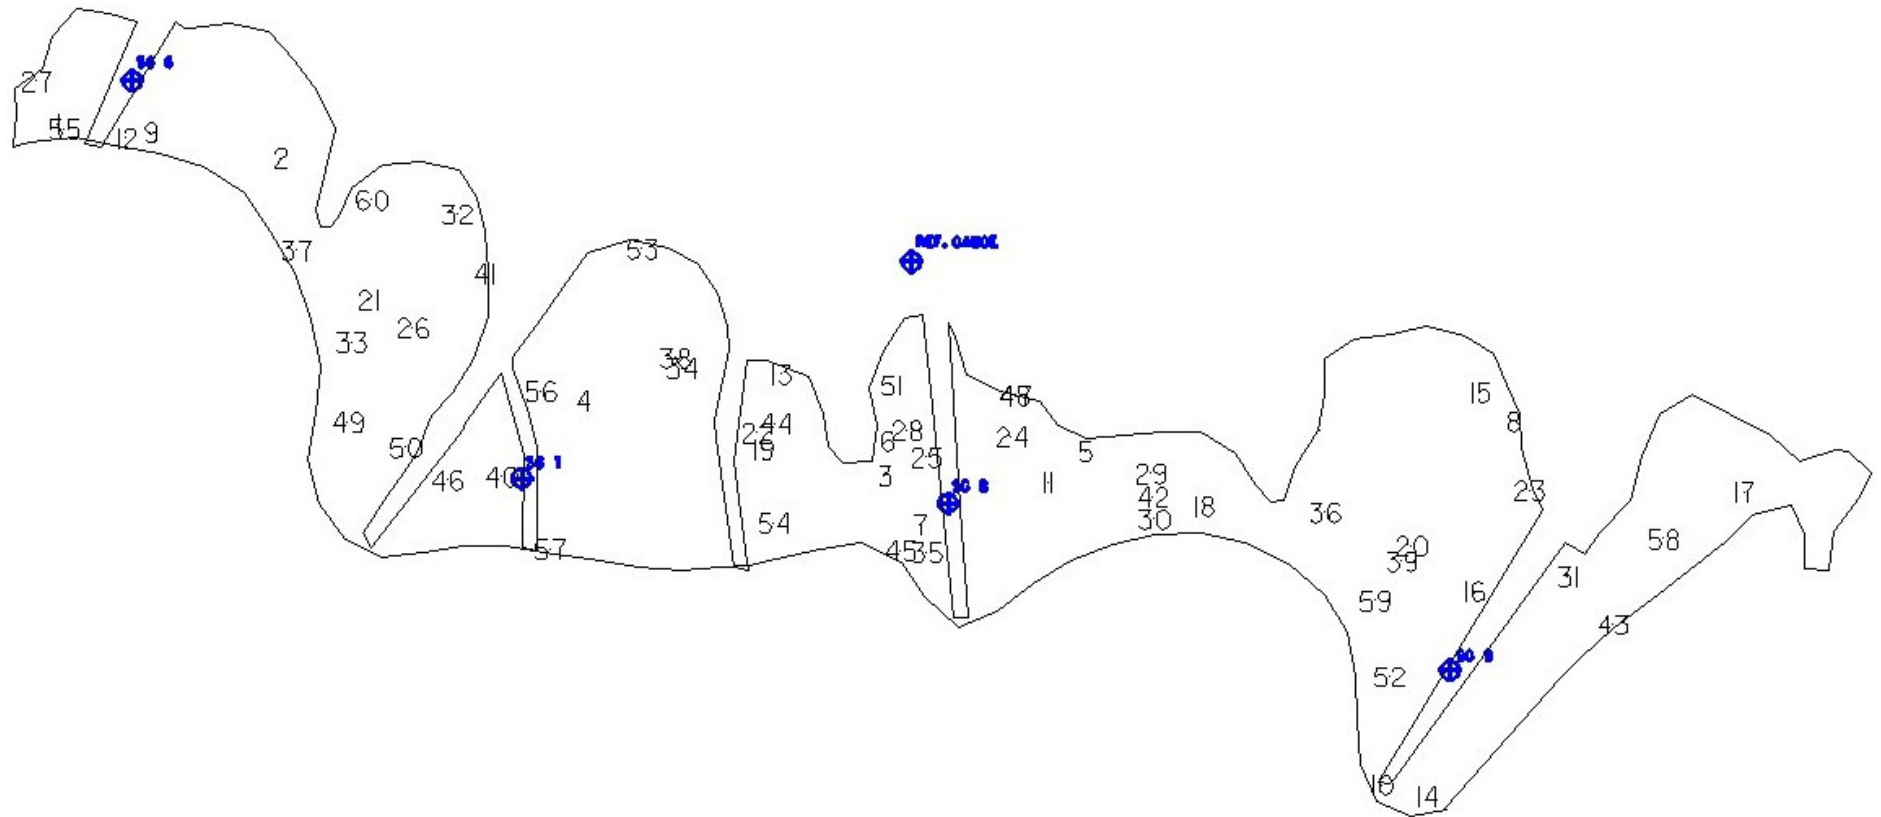
Campbell Creek (Phase II - North Side) 2010 Marsh Grass Random Plots

Site Notes: The number of plots the species were found in is listed in parentheses (i.e. 5 of the plots contain cattail) cattail (5), phragmites (9), *Aster* sp. (24), marsh-elder (22), *Scirpus* sp. (9), stinkweed (21), *Juncus* sp. (7), water grass (4), bearded sprangletop (3), and saltgrass (3).
